TECHNICAL BULLETIN

11/14

G/E401 & G/E402 & F Variant Fryer Controls Wiring Modification

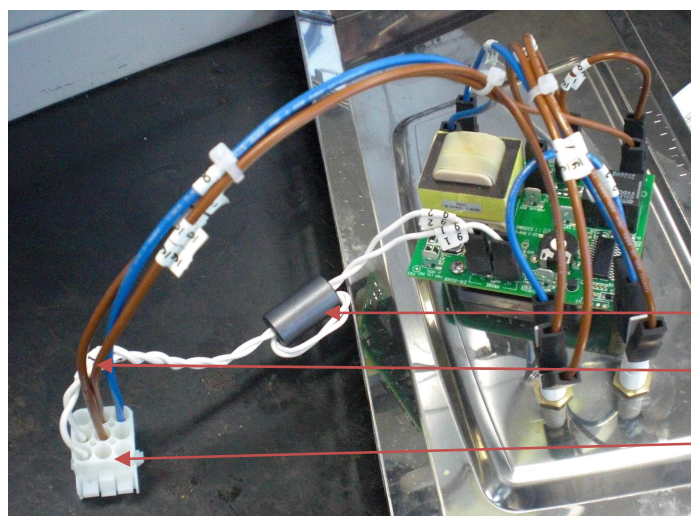
Fig 1.

* The possible fault manifests itself in two possible ways:

- Intermittent trips of safety thermostat. Fryer works ok again, for a period of time, once safety thermostat is reset.
- Intermittent failures to call for heat when required. Fryer works ok again, for a period of time, once mains power is recycled.

E & G401 & F variants FAST controller showing loom with probe wires twisted and ferrite bead added.

Replacement loom spare part number for G or E401 & 401F: 536300043.

Available as replacement kit. See spares number above.

After replacement of loom kit, test fryer and ensure all functions are operating correctly and within specification.

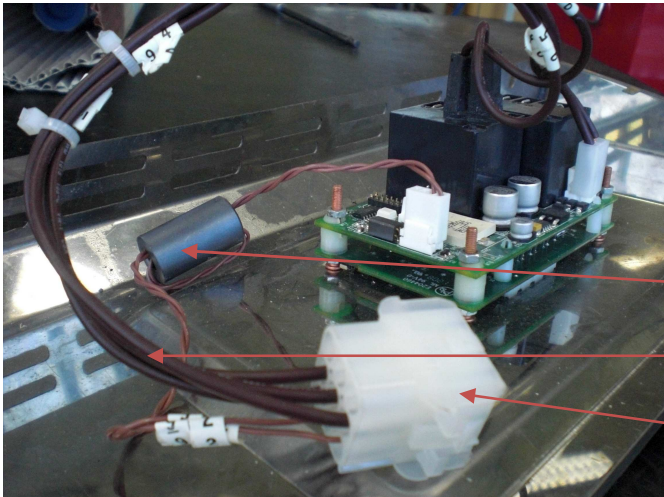
Fig 2.

E & G402 & F variants FAST controller showing loom with probe wires twisted and ferrite bead added.

Replacement loom spare part number for G or E402 & 402F: 536300044.

Available as replacement kit. See spares number above.
